FUNDAMENTAL MECHANISMS OF TENSILE FRACTURE IN ALUMINUM SHEET
UNIDIRECTIONALLY REINFORCED WITH BORON FILAMENT

Thesis submitted to the Graduate Faculty of the
Virginia Polytechnic Institute and State University
in partial fulfillment of the requirements for the degree of

DOCTOR OF PHILOSOPHY

Materials Engineering Science

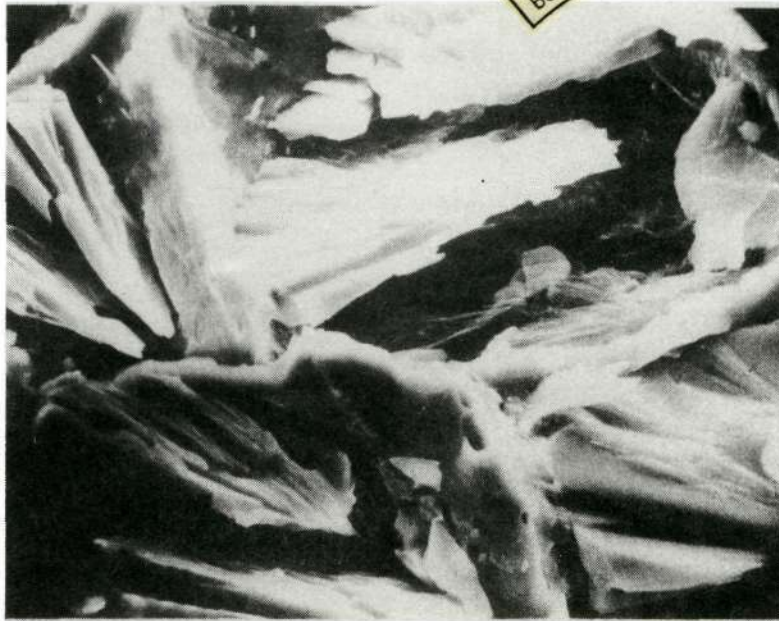
Figure 12. - Typical boron filament fragments in a transverse noncumulative fracture surface, 3.9 mil filament diameter.

The shapes and arrangements of fragments associated with the fracture of filaments were typified by those shown in Figures 12, 13, and 14. No attempt was made to interpret the markings on fragment surfaces. Figure 12 shows the general appearance of fragments in a single transverse fracture surface. Figure 13 does likewise, but also serves to focus attention on the regions of separation between constituents of well bonded composite. The matrix-matrix bond (denoted by arrow) has ruptured only within a
